Section 3

The Building Exterior

BELLE GROVE HISTORIC DISTRICT

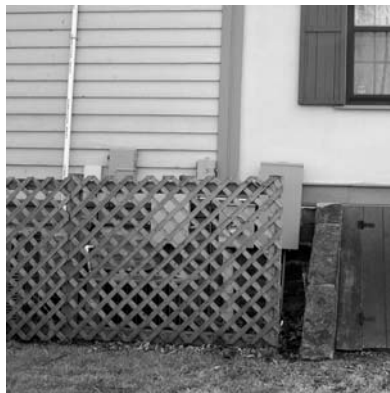
If replacement of HVAC equipment is necessary, if adding air conditioning to the historic building or if designing new construction, consider the use of a geothermal system. Not only is geothermal an energy saver, but it also allows for removing existing ground mounted condensing units which are not historic. Thus, there will be no equipment imposed on the building facade.

If new air conditioning condensing units are to be used, it is necessary to screen them from view from the street. To screen from the street will require at least two (2) screens set at 90° to each other so that passers-by will not see the units on the side of the building or from the front.

HVAC unit(s) should be placed in a rear area to diminish view and the operational noise from the unit. Also, units that are placed between two buildings, or other type structures, can provide a source of heat and moisture that may encourage the growth of algae and mildew fungi.

In order for condensing units to operate properly, an open area around the unit and sometimes an open screen is required. This open space allows the fan to not be overworked. Thick bushes or shrubs placed too close to the unit can also cause stress on the fan unit. A lattice wood screen can be a good solution for this.
